A Laboratory Study of the Stability of Sand-Filled Nylon Bag Breakwater Structures

by
Robert Ray

MISCELLANEOUS REPORT NO. 77-4
MARCH 1977

U.S. ARMY, CORPS OF ENGINEERS
COASTAL ENGINEERING
RESEARCH CENTER

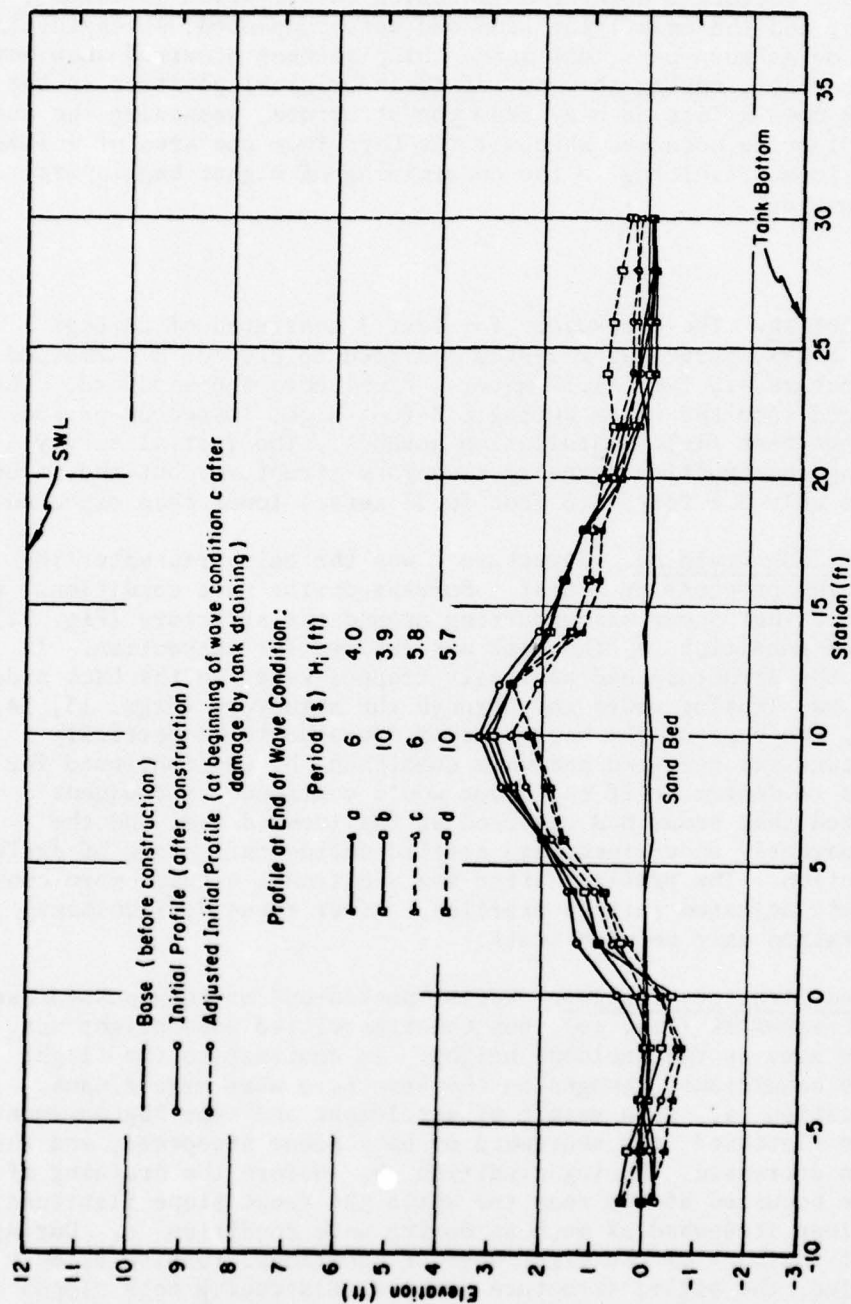
Figure 12. Test I. Changes in structure I average profile for four wave conditions.

b. Midtest Tank Draining. Structure I was the only breakwater inspected during the progress of a test. Surveys during wave conditions a and b indicated that scour was occurring around the structure (Fig. 12). After 2 hours of condition b, the tank was drained for inspection. It was noted that the structure had partially trapped water on the back side and that water was leaking under and through the structure (Figs. 13, 14, and 15). Also, two bags on the bottom layer appeared to be partially emptied. The tank was refilled and wave condition b was continued for another 4 hours to determine if the scour would continue. Subsequent surveys indicated that scour had occurred at the leeward toe, and the breakwater, apparently undermined, had settled during this stage of draining and wave action. The profiles after the additional 4 hours were considered to be the adjusted initial profiles. After these difficulties, the tank was drained only between tests.

c. Wave and Structure Changes. Waves "peaked-up" as they passed over the submerged breakwater (Fig. 16), but the transmitted wave height was essentially the same as the incident height. In contrast to the slight changes in wave conditions, changes in the structure were significant. Under wave condition a, as a result of settlement and some bag movement, the front slope flattened, the shoreward or back slope steepened, and the crest elevation decreased. During condition b, before the draining of the tank, scour occurred at the rear toe while the front slope flattened and the back slope steepened as much as during wave condition a. During the draining of the tank or the first hour of additional running after the tank was refilled, the entire structure settled, flattening both slopes and reducing the crest elevation. As wave condition b was continued for 3 more hours, sand covered the seaward face and a bag on the crest shifted seaward. Both faces settled during wave condition c; however, a bag moved onto the top of the front face and a layer of sand was washed away from the front toe, steepening the front slope. The sand removed from the

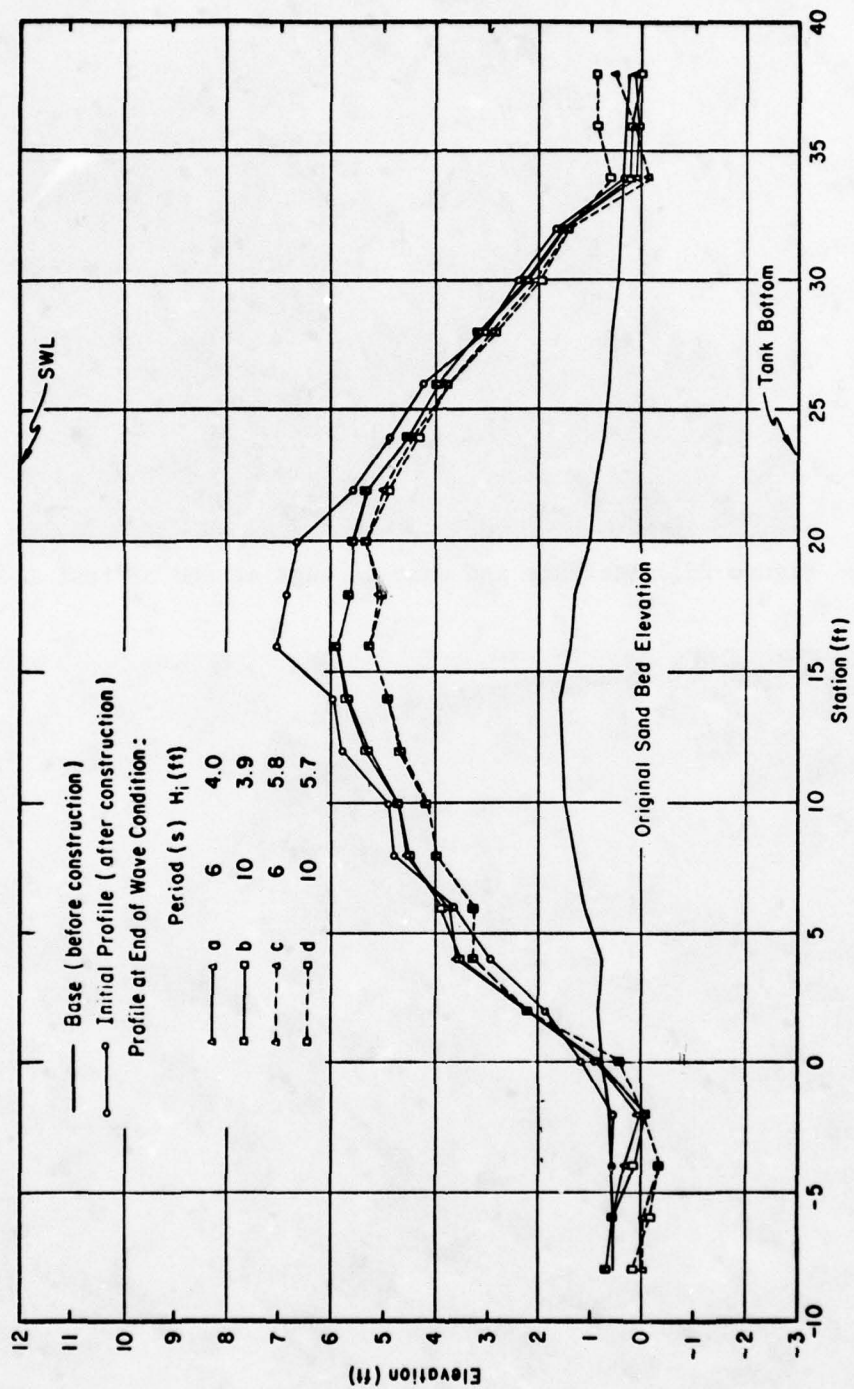
Figure 24. Test II. Changes in structure II average profile for four wave conditions.

a. Configuration Changes. In general, all four of the structures lost crest elevation during the tests (Figs. 12, 24, 33, and 48). The overall changes in configuration differed among the structures. Structure I was symmetric until damaged during the midtest draining of the tank, then the back slope flattened and the front slope steepened during wave conditions c and d. Although the crest of structure II broadened as bags were displaced during wave condition a, the structure was symmetric until wave condition c, then the back slope flattened more than the front slope. The crest of structure III lost bags and broadened during wave conditions a, b, and c, steepening the back slope in the process. The front slope

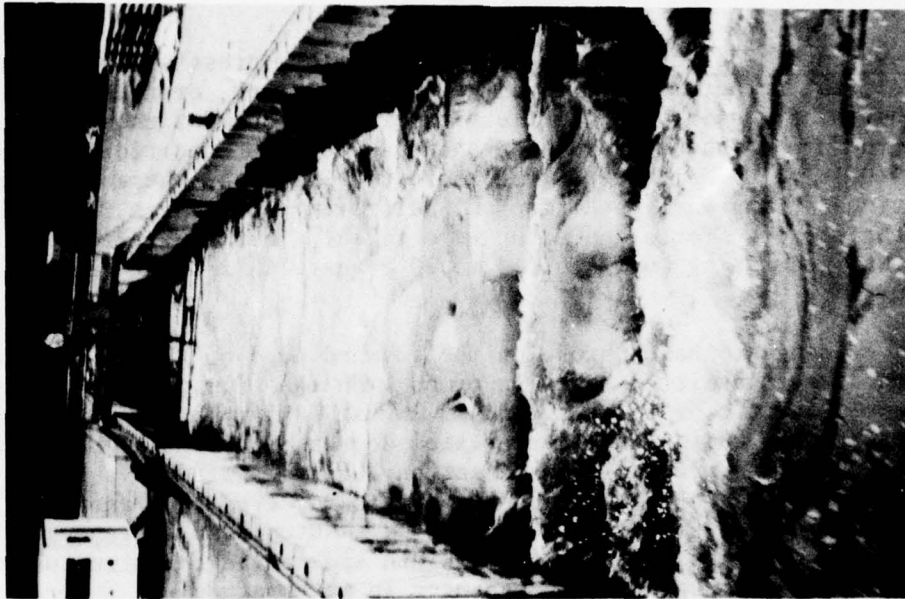
Figure 32. Breakwater crest under wave trough during wave condition a (test III).

d. Structure Changes by "Low" Waves. During the first hour of wave condition a, the seaward row of the top layer of bags was displaced onto the front face and the shoreward row of the top layer was displaced into a pile on the backface, steepening both slopes, widening the crest, and lowering the crest elevation below the stillwater line (Figs. 32 and 33). A single row of four bags was used to rebuild the crest of the structure to its original height. During the next series of 90 waves, run in bursts, the new layer was removed onto the back slope (Fig. 34). The wave condition was continued for an additional 1 hour and 50 minutes (1,100 waves) with little additional change to the structure. Wave condition b caused a small amount of bag movement at the seaward edge of the crest.

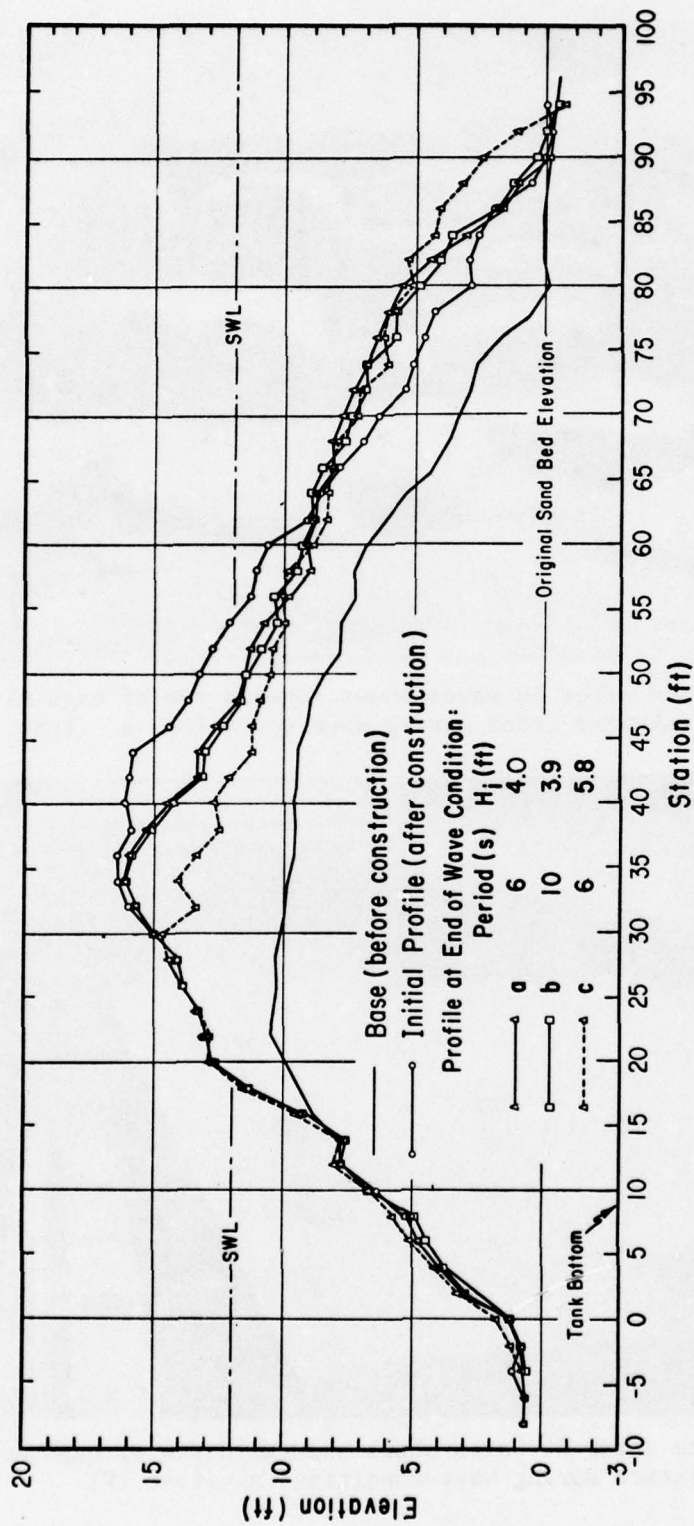
Figure 48. Test IV. Changes in structure IV average profile for three wave conditions.

c. Structure Changes. During the first 60 waves of condition a, many bags were dislodged from the front face of structure IV, the damage starting in the third layer from the top and progressing upward to the top seaward row of bags (Fig. 45). As the wave condition was continued, the seaward row of bags in the upper part of the front face (i.e., from the crest to 3 feet below the stillwater level) slumped to the lower part of the face (Fig. 46), leaving the shoreward row on the crest almost untouched (Fig. 47). The front slope flattened dramatically and the crest lost 38 percent of its width but little of its height (Fig. 48). Wave condition b moved scattered bags on the front face downslope about 1 foot, but did not change the height or front slope significantly. During the first burst of waves of condition c, three bags from the remaining row on the crest were displaced onto the backface, decreasing the crest elevation. After the 60th wave, bags on the front face began moving with the wave action, slowly sliding down the face. After 440 waves, the whole upper half of the front face began slumping toward the toe and the bags remaining on the top of the structure began moving shoreward. All bags visible above water appeared to be moving. The slope of the upper half of the front face continued to flatten as the crest elevation continued to decrease. Wave

steepened during wave condition a, then flattened during wave conditions c and d. The front slope of structure IV flattened radically, but the back slope changed only slightly, resulting in a narrowed crest width.

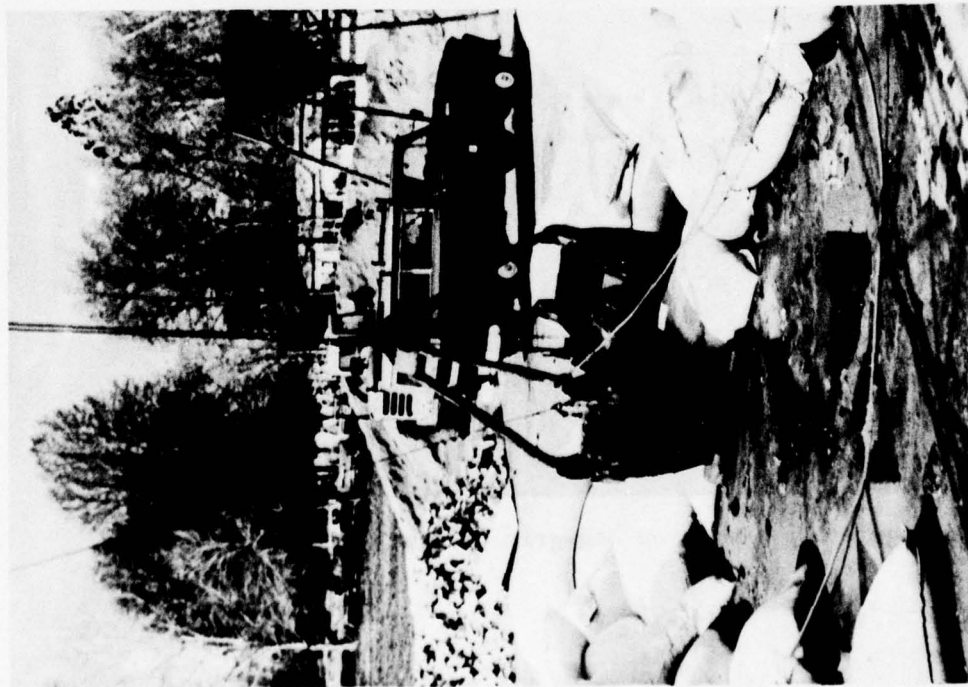
Figure 51. First bag-grip design picking up bag.

The method of placing bags successfully produced the planned structure when the correct underwater dimensions of the bags were known and the bag-dropping equipment was positioned according to a placement diagram; however, handling the bags during placement was a problem. The crane clam was equipped with a bag grip made of two short sections of steel pipe bolted to the jaws (Fig. 51). Torn bags found in structures I and II were suspected of having been ripped on the ends of the pipe sections (Fig. 52). The sections were extended and pipe elbows were welded to the ends to protect and give additional support to the bags (Figs. 53 and 54). In cold weather the stockpiled, sand-filled bags froze solid at night, making the bags difficult to grip and more susceptible to tearing. A tent of black plastic placed over the stockpile at night and warmed by a small kerosene heater succeeded in keeping the bags pliable enough to be gripped without further damage by the modified clam jaws.

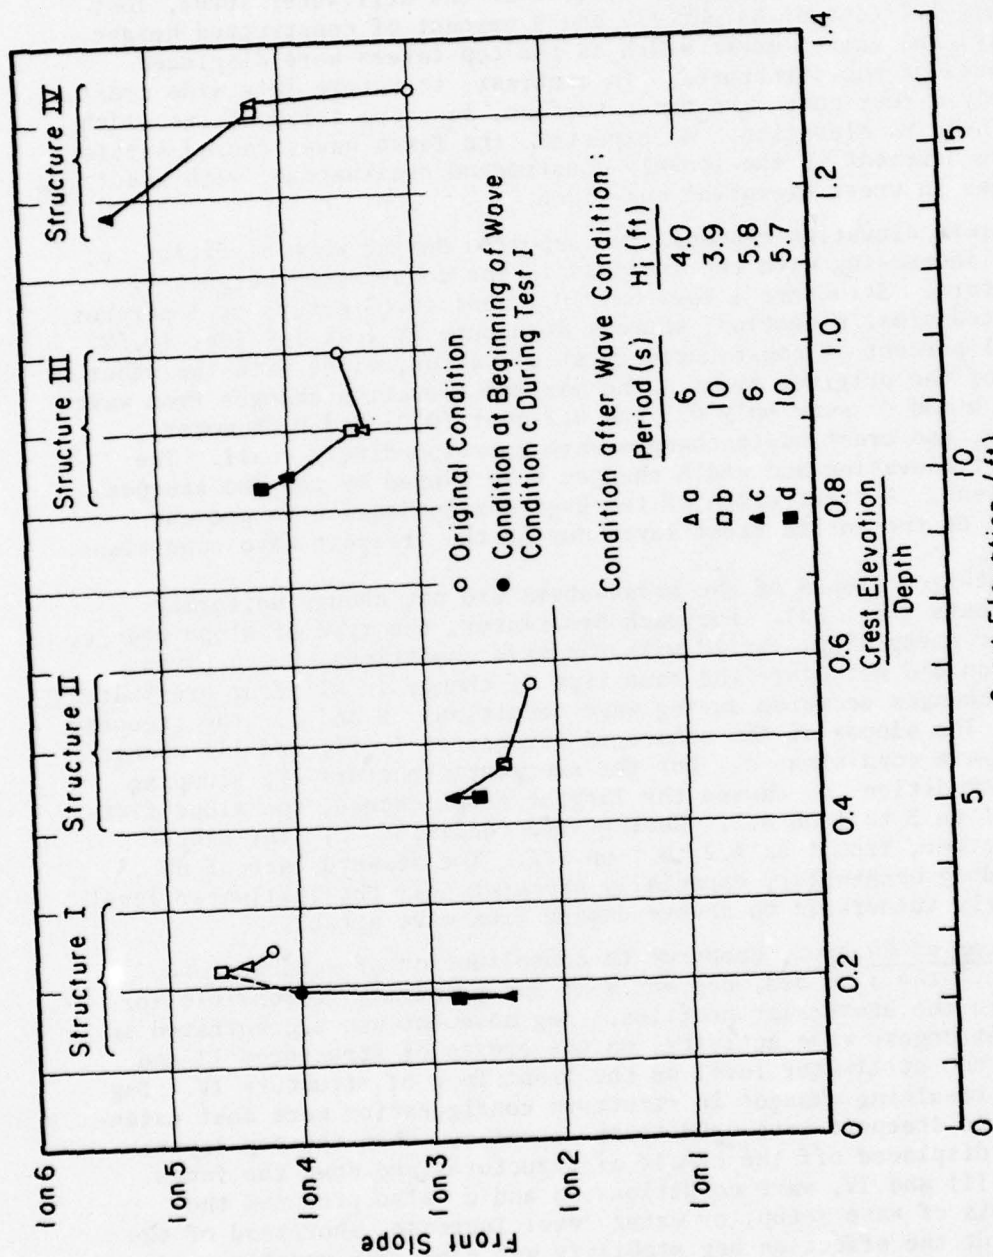
Figure 55. Effects of wave action on structure configuration.

Crest elevations for structures I, II, and III decreased most and crest widths for structures II, III, and IV changed most during wave condition a. Structure II with a crest submerged nearly 50 percent of the tank depth, and structure III with a crest at the stillwater level, lost approximately 1.2 feet of height (17 and 9 percent of constructed height, respectively) and gained crest width as the top layers were displaced down the faces of the structures. In contrast, structure IV's wide crest, approximately 4 feet above the water surface, lost one-third of its width but maintained its elevation. As expected, the first waves caused settlement and bag movement in the loosely constructed breakwaters, with resulting large changes in crest elevation and width.

The front-face slopes of the breakwaters did not change uniformly during the tests (Fig. 55). For each breakwater, the type of slope change, flattening or steepening, varied with the wave conditions, but a given wave condition did not cause the same type of change in all four breakwaters. The largest changes occurred during wave conditions a and c, the steepest conditions. The slopes of the submerged structures I, II, and III changed most during wave condition c. For the emergent structure IV, slumping during wave condition a caused the largest slope change, the slope flattening from 1 on 3 to 1 on 4.2. During wave condition c, the slope flattened further, from 1 on 4.2 to 1 on 5.3. The seaward face of an emergent sandbag breakwater, especially the area near the stillwater level, is particularly vulnerable to severe damage from wave attack.

Experience in construction of test breakwaters has shown that achieving a design slope for a structure built in overlapping layers by dropping bags through water is extremely difficult. The method of bag placement and the instability of the individual bags ensure that some change in the slope will occur as a result of wave action immediately after construction. The total changes in the front-face slopes of the test structures (Fig. 55) are, when compared with the final slopes, indicative of the design slopes needed to minimize change. The front slope changed from 1 on 4.2 to 1 on 2.8 in test I, 1 on 2.2 to 1 on 2.6 in test II, 1 on 3.6 to 1 on 4.2 in test III, and 1 on 3 to 1 on 5.3 in test IV. The final slope for test IV is not completely comparable to the final slopes from the other tests since structure IV was not subjected to wave condition d. Based on changes in structures II and III during wave condition d, the final slope of structure IV would be 1 on 5.5 or flatter, but the large amount of slumping on structure IV compared to the other structures, the result of the different forces on an emergent breakwater, makes such an estimate questionable. Neglecting test I and the effects of midtest tank draining, the higher the breakwater, the flatter the final slope. The flattest slope from structure I, measured during wave condition b before the tank was drained, was 1 on 4.6, between the final slopes of 1 on 4.2 for structure III and 1 on 5.3 for structure IV. Slope changes by the wave conditions in those three tests might have been minimized by building the initial front slope at 1 on 5.
